Your survey report

Property address 10 Heron Road Belfast BT3 9LE

Inspection Date 11th February 2021

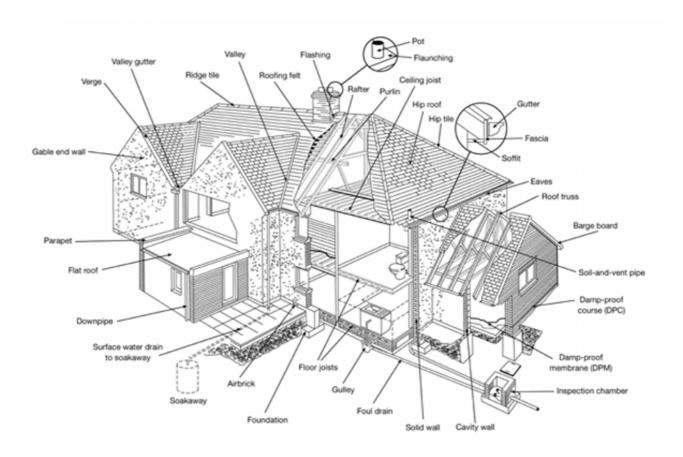
Typical house diagram

This diagram illustrates where you may find some of the building elements referred to in the report.
